THE TOKAI MURA CRITICALITY ACCIDENT

A serious criticality accident occurred on September 30, 1999 in Japan at a nuclear fuel manufacturing facility run by the Japan Nuclear Fuels Conversion Company (JCO) at Tokai Mura. By reconstructing the circumstances of the accident, its different phases have been characterized and the role played by the human factor has been revealed.

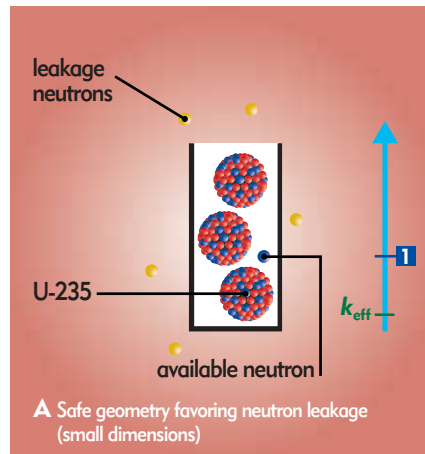
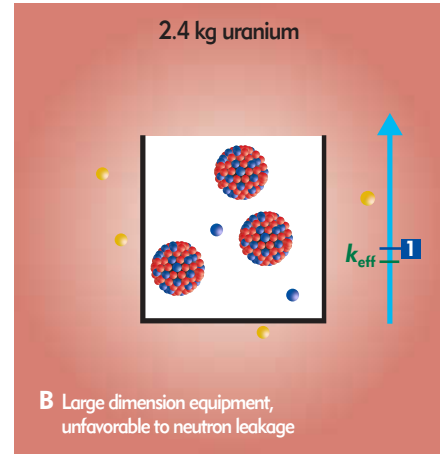
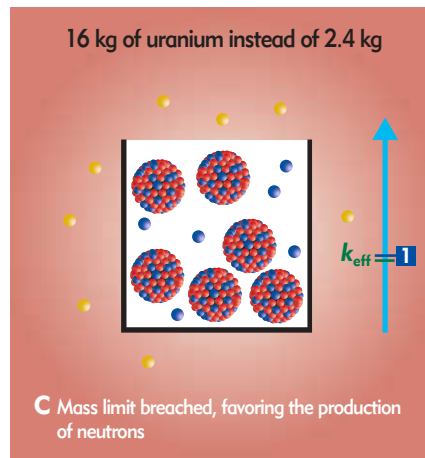
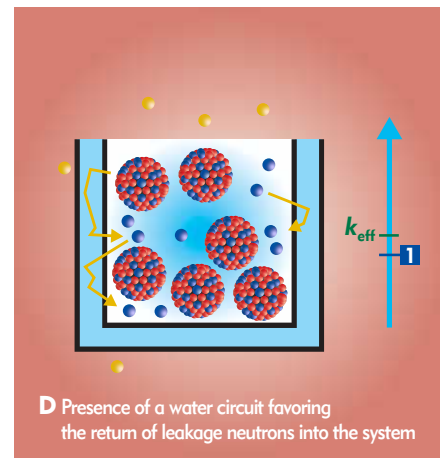
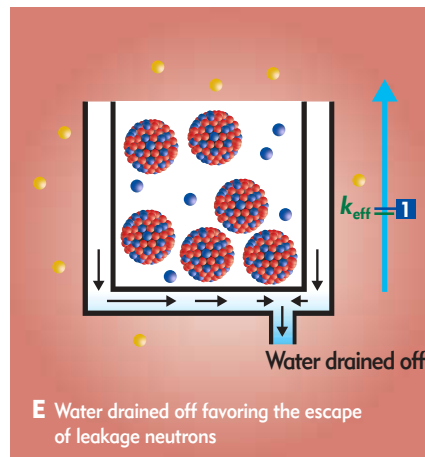
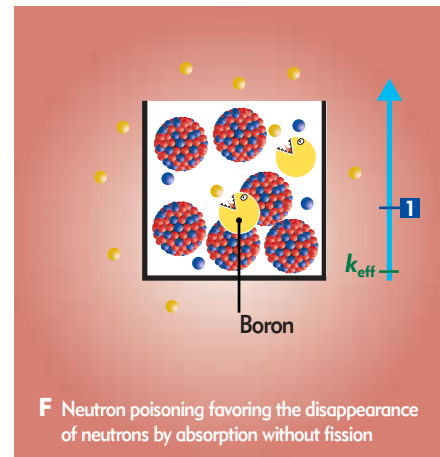
Technically, three factors led to the accident. The first was replacing safe geometry equipment with larger equipment, resulting in a much lower number of neutrons able to escape from the equipment and so an increase in the value of the multiplication factor k_{eff} (figure 1B). Secondly, the mass limit of 2.4 kg was not complied with in the large dimension equipment.

Figure 1. The different fissile medium configurations involved in the 1999 accident. Figure 1A shows the safe geometry equipment with capacity judged to be too small. In figure 1B, the equipment is of large dimensions where the system would remain non-critical if the mass had remained below 2.4 kg. Figures 1C to 1F show how the situation developed, with the k_{eff} value relative to 1 shown on the right hand side.

The operator then tried to drain the cooling circuit. This attempt failed, so the workers acted to break the pipework, thus stopping the accident (figure 1E). Without water around the tank, the accident would not have happened for 16.6 kg of uranium, but would have required a larger quantity to become critical (see *The risk of criticality and its prevention in nuclear plants and laboratories and during transportation*).

Next, boron, a nuclear poison which absorbs neutrons (see *Control and operation of pressurized water reactors*), was introduced into the tank, reducing the k_{eff} value significantly and definitively (figure 1F). Emergency teams could then get access and place biological barriers (including sandbags) against the walls surrounding the equipment concerned in order to reduce the ambient radiation near to the tank.

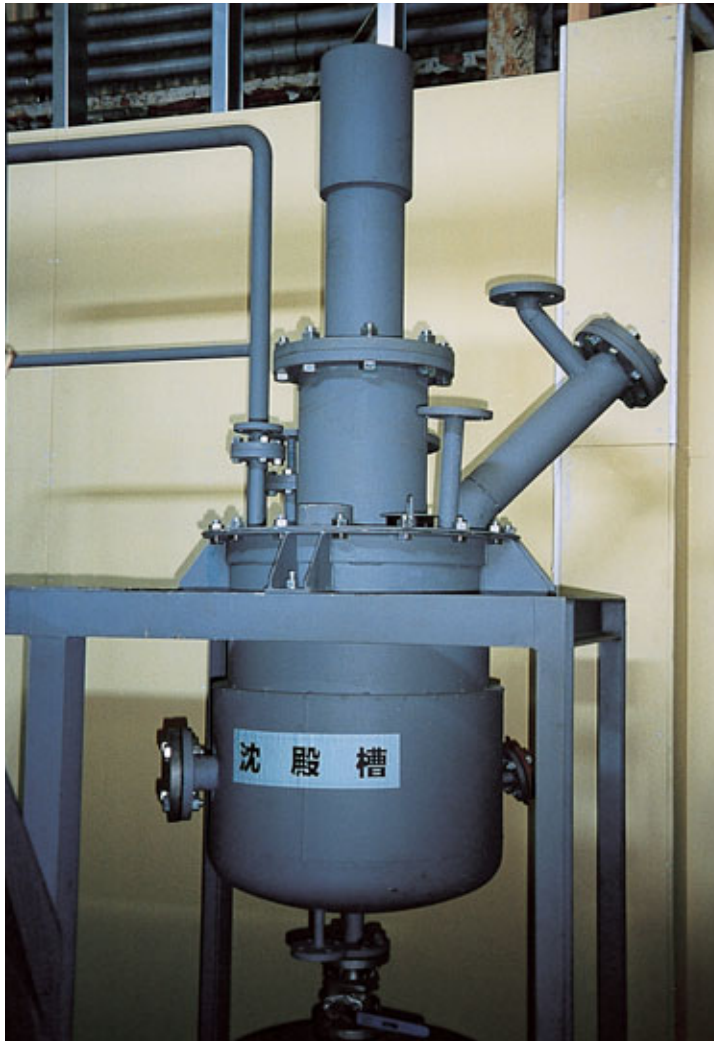
Full scale model of the settler-precipitator produced for the accident enquiry.

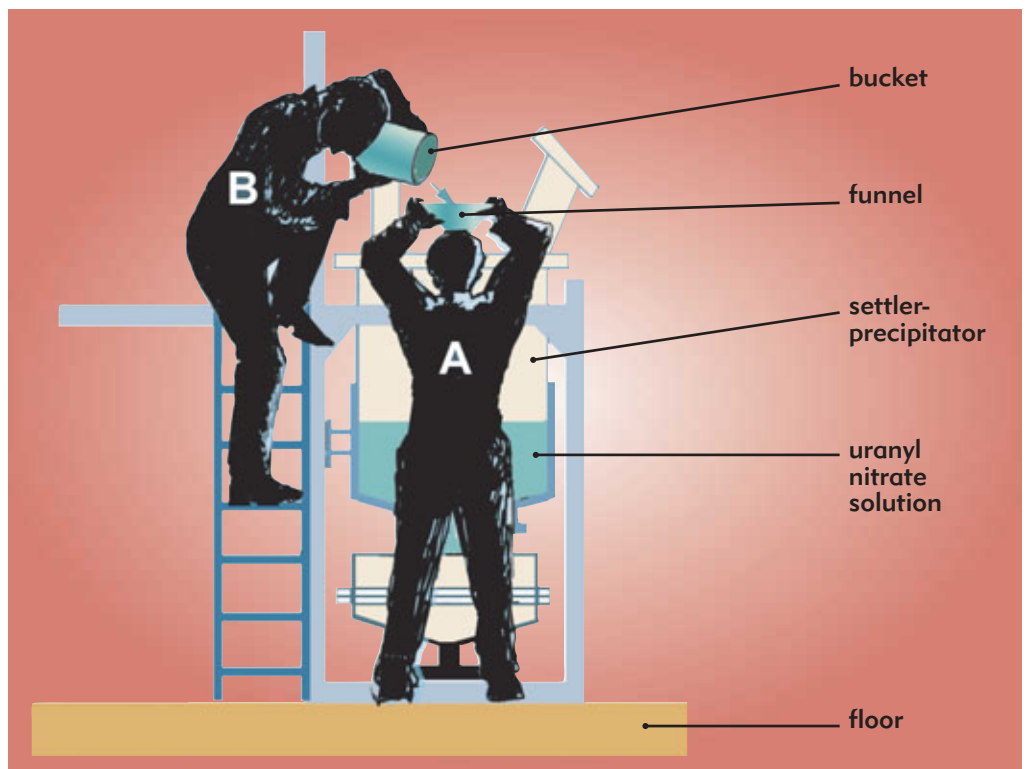
Figure 2. Position of the two most exposed operators relative to the settler-precipitator when the Tokai Mura accident started.

During the accident, 136 people on the site were irradiated at very variable doses, three of them seriously. Two employees involved in the operations and located next to the tank died, after three and seven months of intensive care respectively. The worse affected of the two (operator A in figure 2) received a dose of 9.1 Sv, almost twice the lethal dose (corresponding to 50% deaths in

an irradiated population without special medical treatment, 5 Sv), while the second operator (B) received a dose of 5 Sv. The supervisor, located in an adjoining room, about 5 meters from the tank, received a dose of 1.2 Sv and may in the long term develop cancer. The other 133 people (emergency personnel, operators acting to stop the criticality accident, government advisors) suffered much less severe exposure and most will certainly have no directly observable effect on their health. They received doses estimated at between 0.1 and 50 mSv. An investigation by the operator revealed that about a hundred other people on the site may potentially have received doses estimated at between 0.01 and 21 mSv. In the vicinity of the site, 160 people living within a radius of 350 meters of the building containing the tank were evacuated, while 320,000 others in a radius of 10 km were advised as a precaution to stay at home until the accident was over. Measurements taken in the air, water and on vegetable products only revealed intermittent trace levels of iodine.
