THE TOKAI MURA CRITICALITY ACCIDENT

A serious criticality accident occurred on September 30, 1999 in Japan at a nuclear fuel manufacturing facility run by the Japan Nuclear Fuels Conversion Company (JCO) at Tokai Mura. By reconstructing the circumstances of the accident, its different phases have been characterized and the role played by the human factor has been revealed.

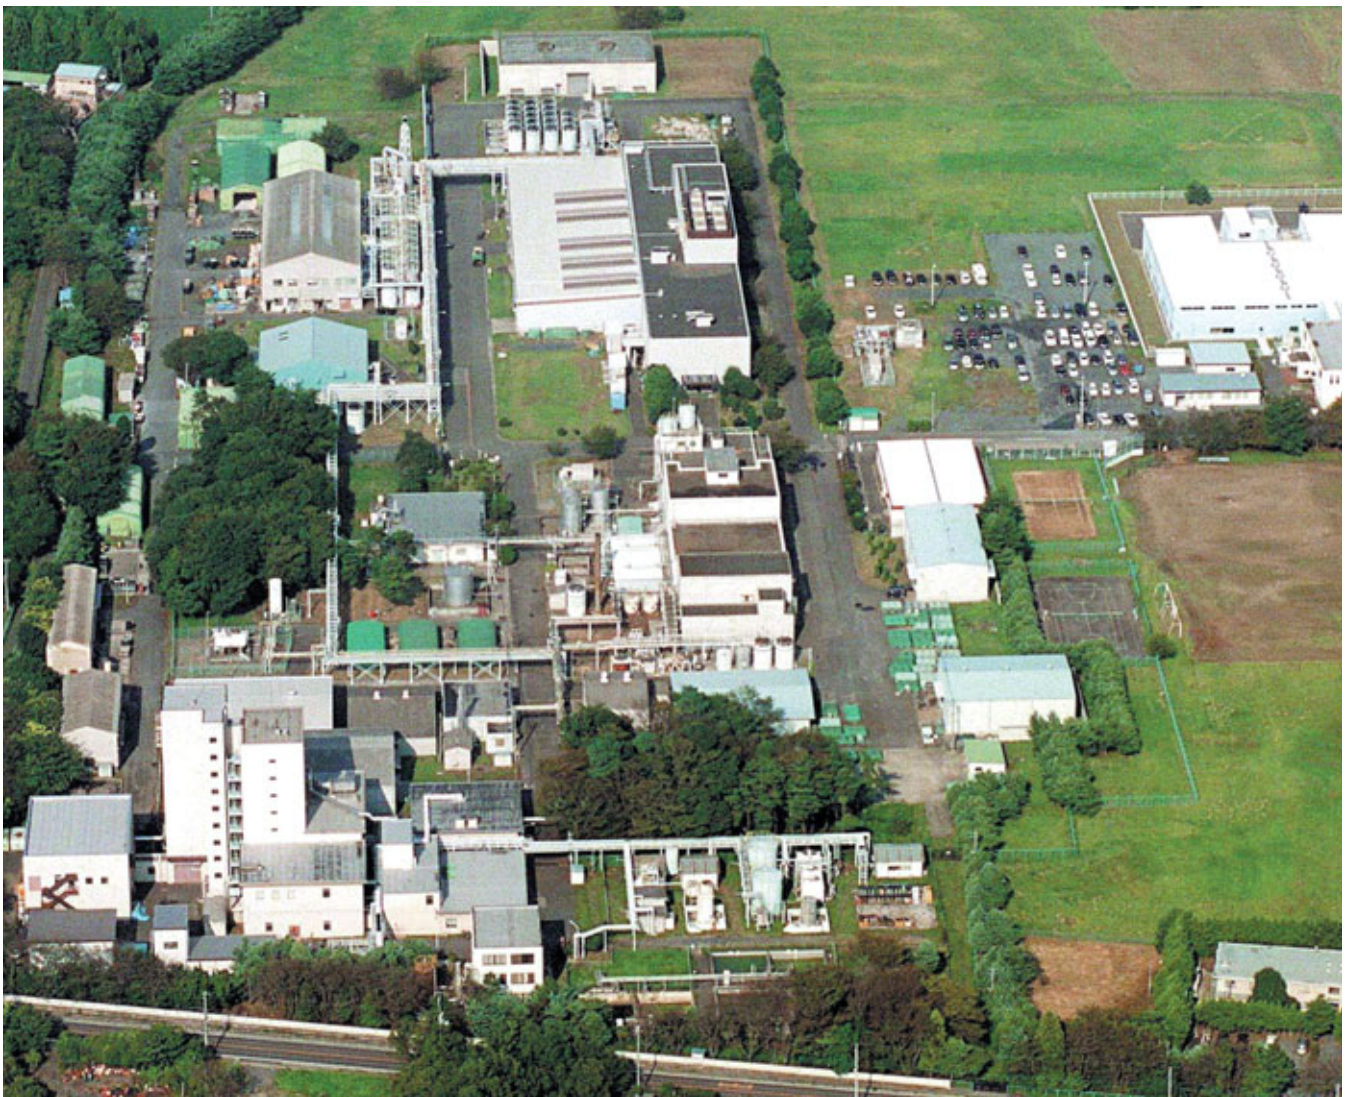
The Japan Nuclear Fuels Conversion Company (JCO) site at Tokai Mura, scene of the criticality accident on September 30th 1999.
